### **Part Three: Where The XJS Rusts and Why**

**“Where the XJS Rusts and Why”** was first published in **Xclusively Jaguar News** in 2009 and is Copyright © 2009 Xclusively Jaguar [www.Xclusively-Jaguar.com](http://www.Xclusively-Jaguar.com) and Just XJS [www.justxjs.com](http://www.justxjs.com)

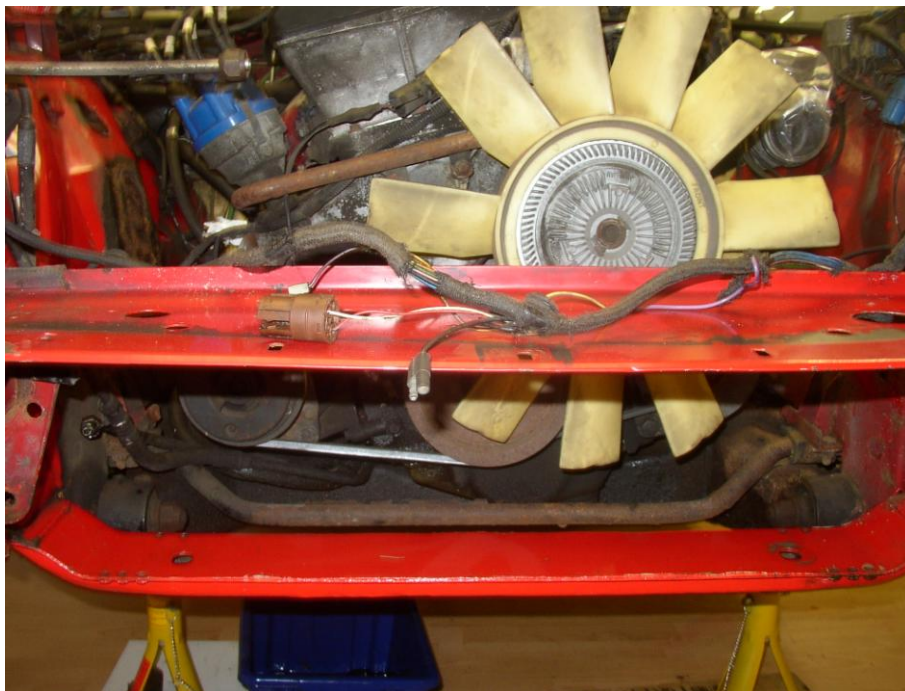
This is not to be confused with the main suspension cross member, that being a different animal altogether. The radiator cross member is a shallow rectangular box section. It bridges the gap between the two chassis legs at the lower front of the engine bay and supports the weight of the radiator to boot. It leads a secret life, covered on top by the radiator and from below by the aforementioned centre panel from the three amigos, it's very hard to see unless you start taking things apart.

So there it sits covered by the radiator, centre panels engine oil and anti freeze. The latter two generally decide the cross member's fate, if you've got a healthy oil leak from the front seal or oil cooler then the cross member (and the centre panel) stand a fair chance of survival. An oil tight engine plus the residue from regular anti freeze changes will see it expire within the obligatory 20 years. Problems can be compounded or relived by the strip of foam that sits between the radiator and cross member. Its there to create an air dam so all the cooling air is forced through the rad and not around it. This foam acts like a sponge, retaining anything which is liquid, be it friend or foe.

The underside of the cross member can be checked once the lower centre panel has been detached. The radiator has to be removed to check the upper section.

**Radiator cross member**

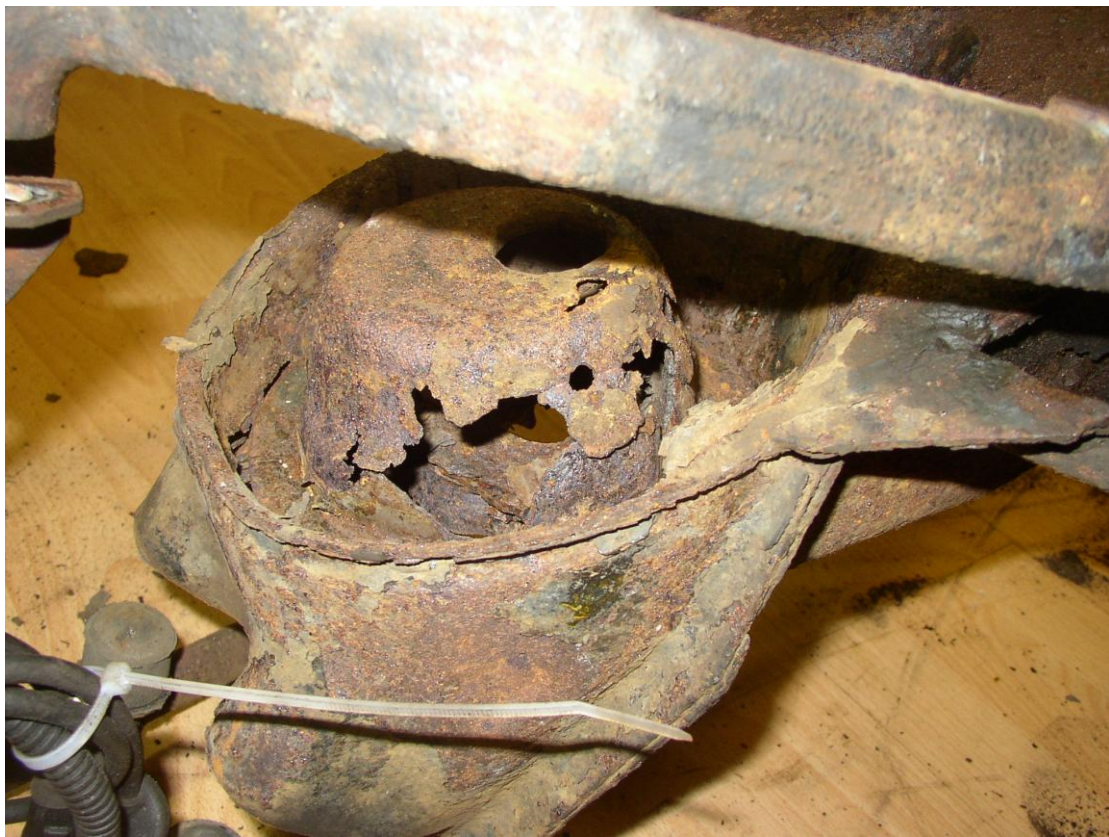
It's not too difficult to check the integrity of these turrets. Place the front of the car on axle stands and remove the wheels. Slide your hand between the inner wing and sloping back face of the spring turret. Press firmly on this face, if you feel a smooth metal surface that doesn't yield then so far so good. If you feel something that resembles soggy crisps then press harder until your fingers go straight through the metal. Have you got super strength? Not this time Superman, just a few issues with your pride and joy!

**Sub-frame spring turret cone**

The next step is to take a lead light and a large flat bladed screw driver. Follow the road spring up to where it locates within the turret. There you will see the spring locating cones. Give these cones a real good poke with the screw driver until you are satisfied the metal is sound or the screw driver disappears into their innards.

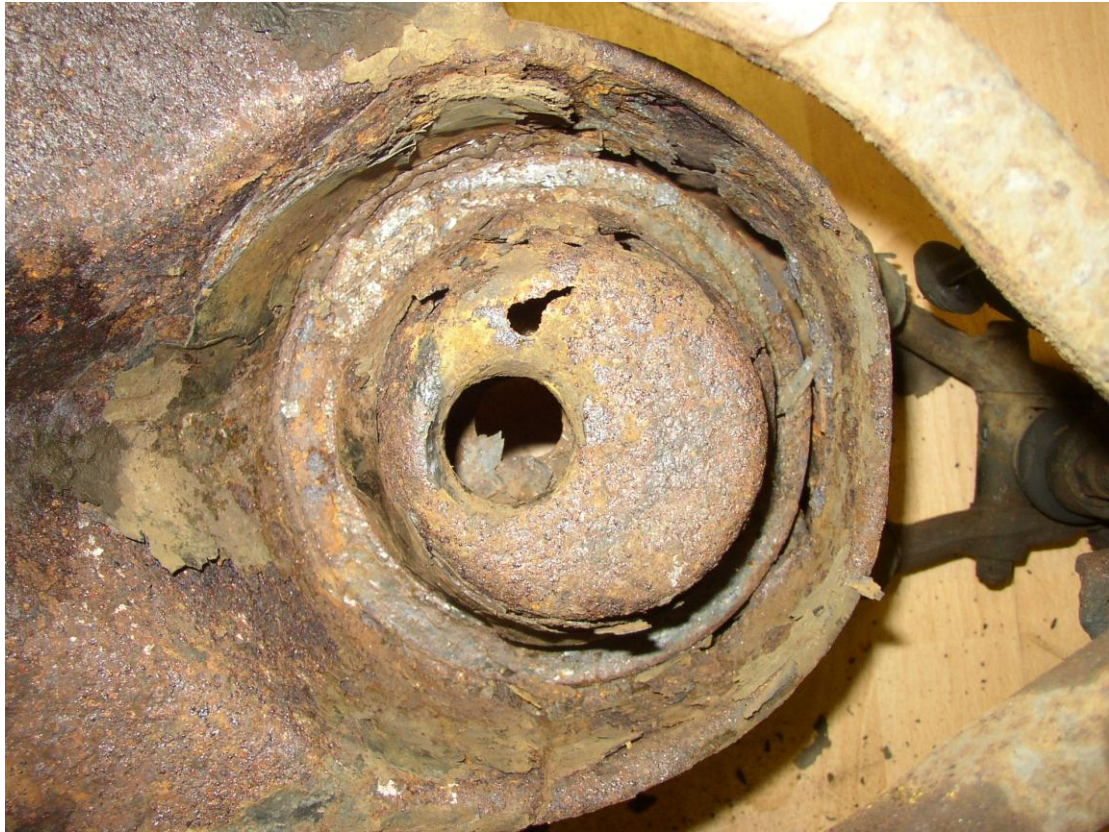
If you've got to step three and all is well then you face a dilemma. The final check involves inspecting where the spring tops actually seat within the spring turret. This cannot be done properly without removing the actual springs (never buy a second hand subframe with springs still in place, you could be in for a nasty shock).

**Sub-frame spring turret showing spring base**

Removing the springs is quite a task involving the correct Jaguar spring compressor. PLEASE, PLEASE do not attempt to remove the springs without this tool, here speaks the voice of experience!!! I cannot stress this point strongly enough, the amount of stored energy in these beasts would launch a space shuttle.

Anyway, I digress, if you've got to this stage and the rest of the sub frame is rot free there is a good chance that the spring seats are also good, but that's your call, Jaguars can be very fickle.

It's advised that any corrosion on a sub frame is terminal, due to the stresses in this area any welded repairs are deemed dangerous to the point of being suicidal.

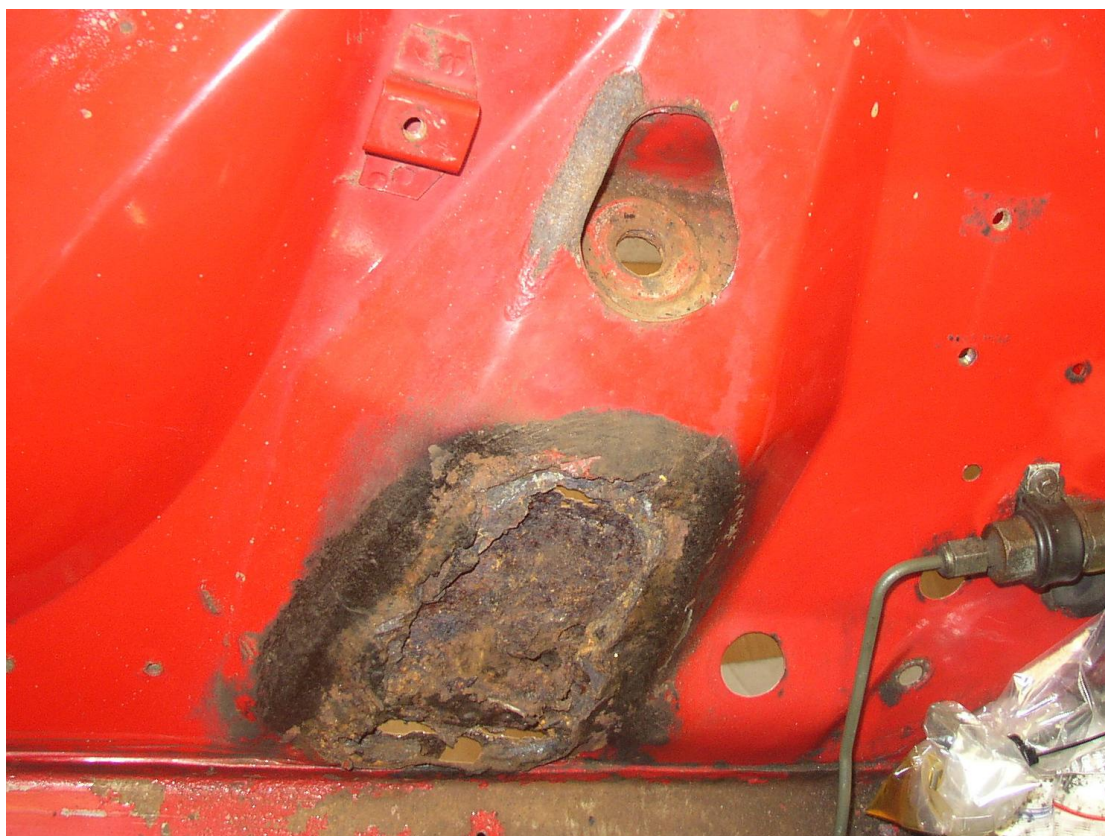
Running side by side with the cross member in the race to rust is the section of inner wing just below the shock absorber upper mount. In the 'cosy' confines of a V12 engine bay these areas are hard to see, obscured by the air filter on the right hand side and by both the air filter and expansion tank on the left, the best way is with a torch and a pair of rust detecting hands. Even then you can only see so much, the expansion tank sits so close to the inner wing that corrosion often jumps the gap and attacks the expansion tank as well. On a six cylinder car any corrosion problems are more easily spotted.

The area below the shock absorber mount has to cope with the forces transmitted by the shocks and so is double skinned for extra strength, here lies the problem. Water finds its way into the small gap between the panels and does its job. For some reason the corrosion is always worst on the engine bay sections, it rarely shows itself on the external areas underneath the wing. If rust has affected both of the panels then things are getting pretty serious, the MOT inspector will want a word in your ear.

**Inner wing corrosion**
